Investigation Plan for Collapsed Adit Area at St. Louis Tunnel

**Rico-Argentine Mine Site – Rico Tunnels
Operable Unit OU01
Rico, Colorado**

Investigation Plan
for
Collapsed Adit Area at St. Louis Tunnel
at
Rico-Argentine Mine Site – Rico Tunnels Operable Unit OU01
Rico, Colorado

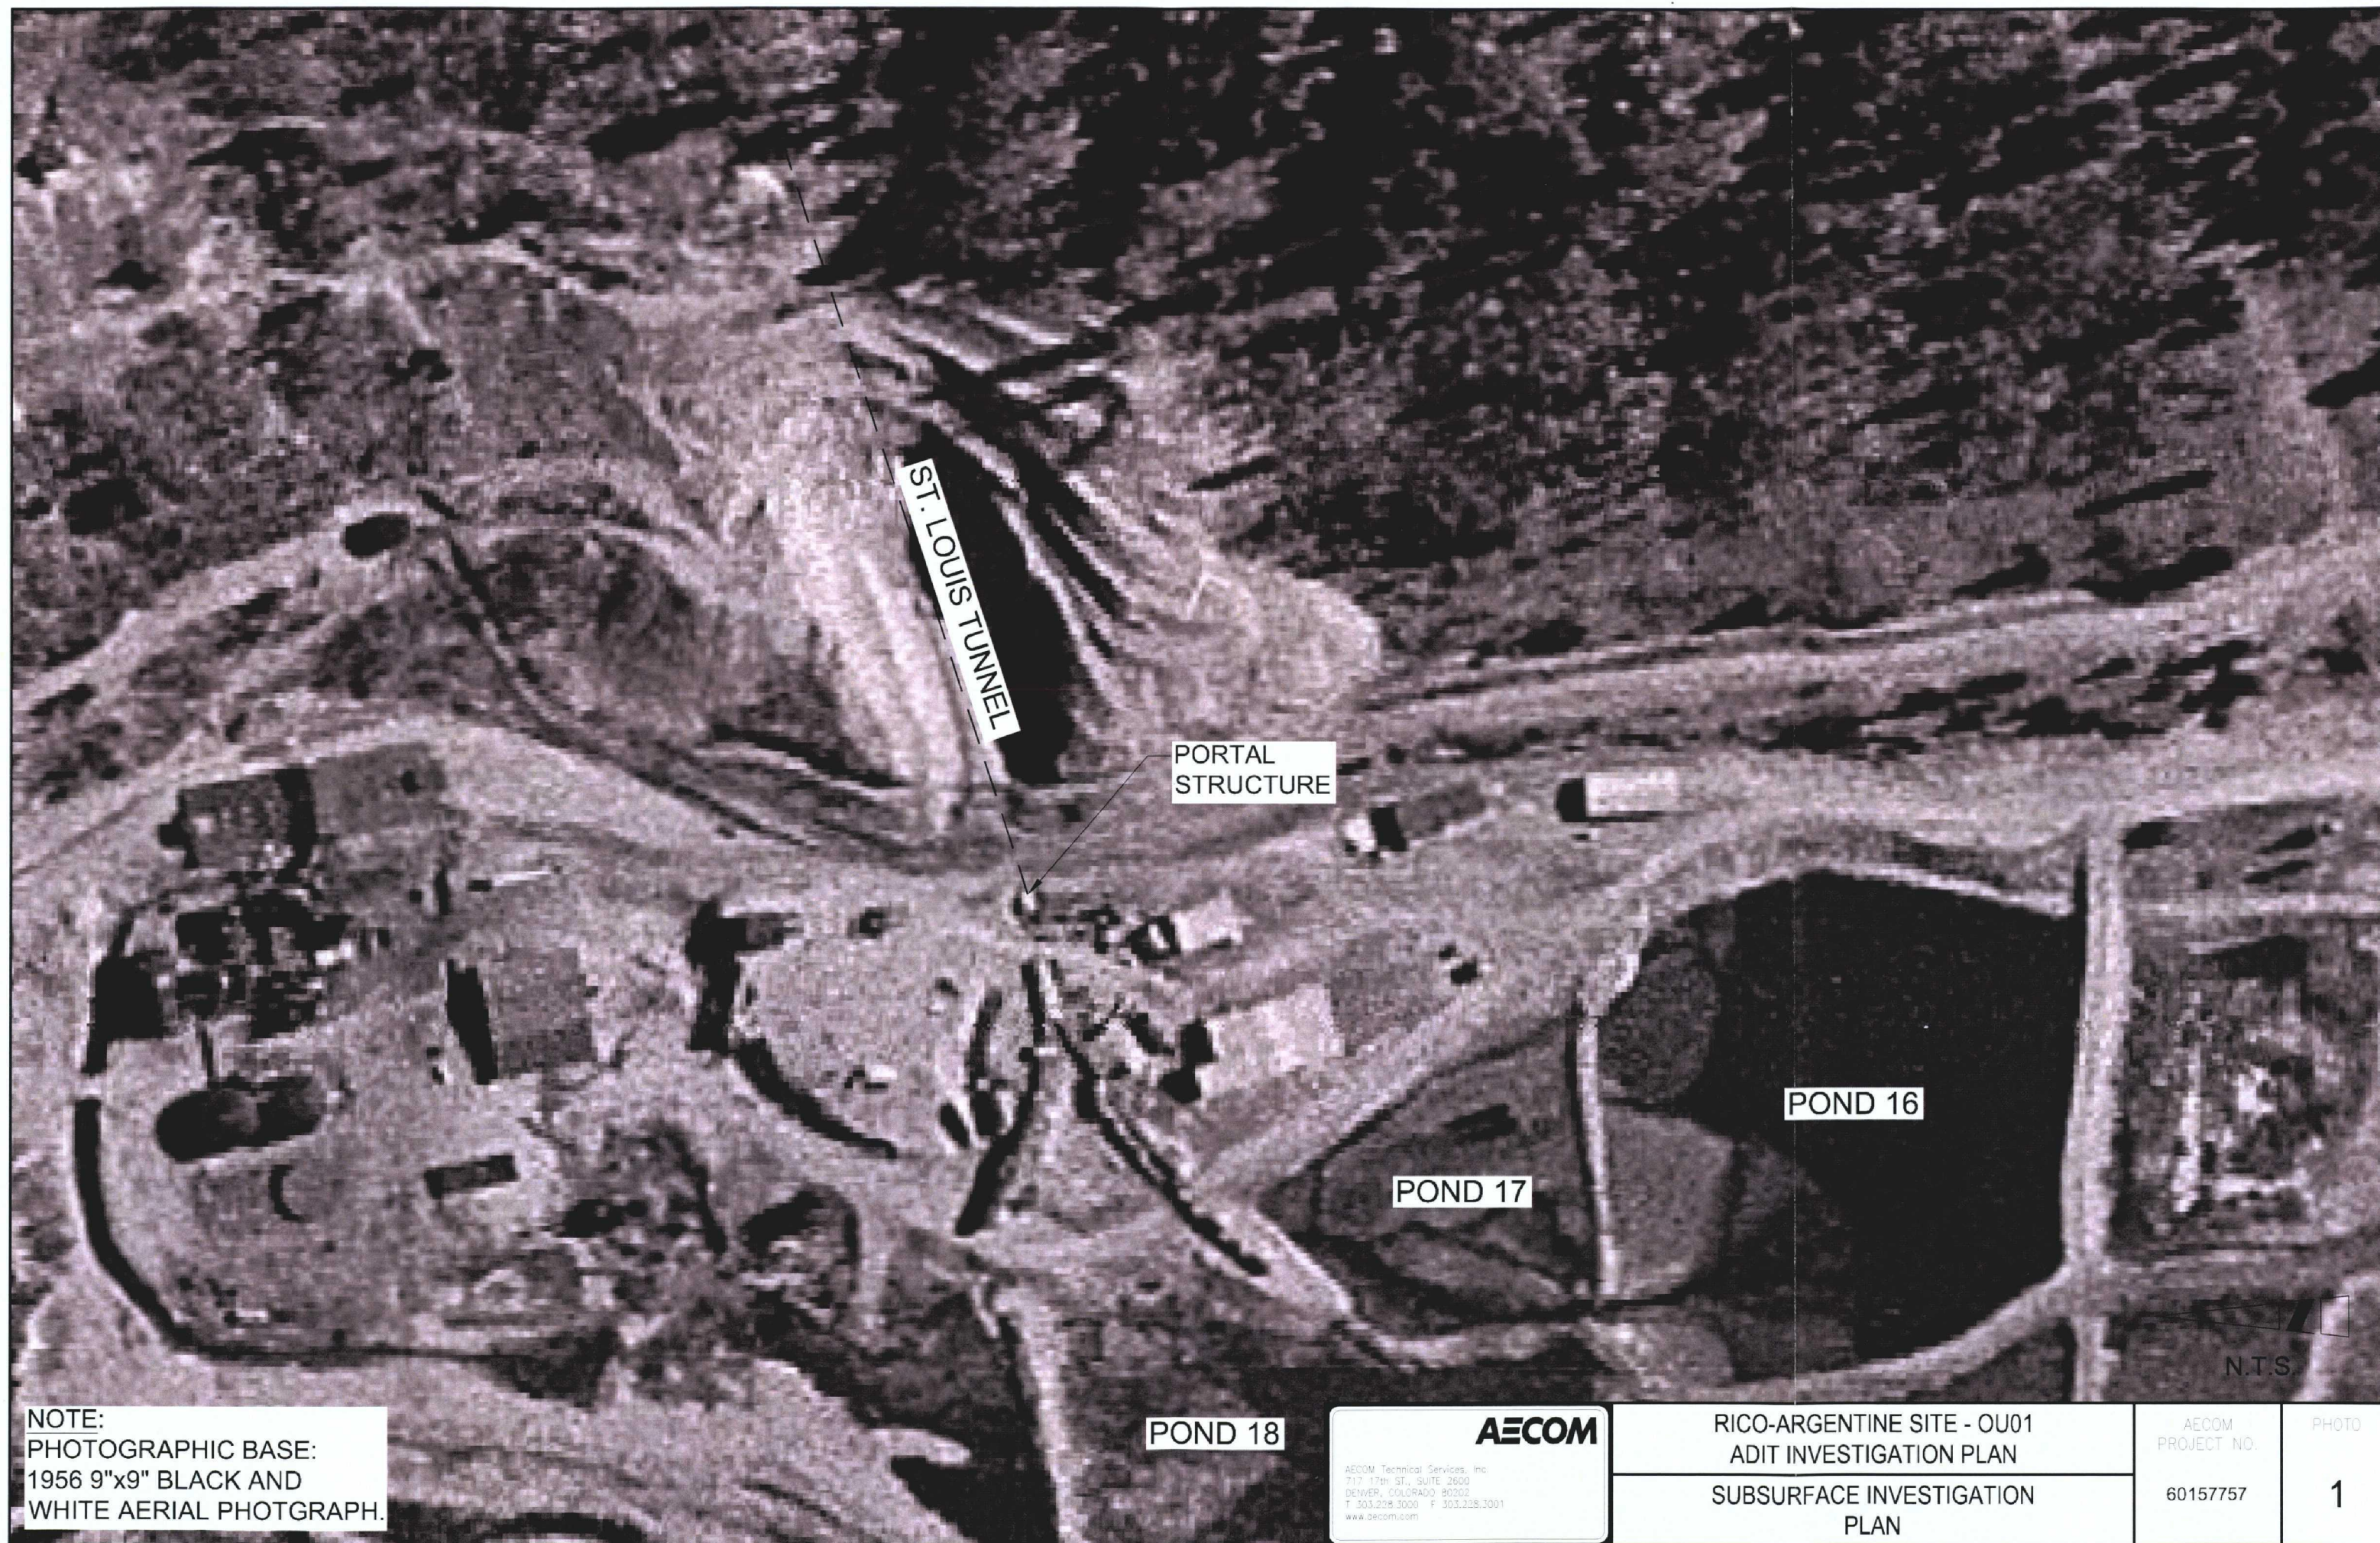
PHOTO

The reason that the area overlying the down-gradient end of the St. Louis Tunnel was originally excavated (as visible in the 1956 aerial photo – Photo 1) is unknown. One theory is that the excavation was made to substantially reduce or eliminate what may have been frequent maintenance of the support in the portion of the tunnel through the colluvium/talus mantling the lower slope of CHC Hill, and generate borrow for other facilities on site in the process. If this was the case, it may suggest that the brow of CHC Hill where Hermosa Formation bedrock is present may not be too far into the hill at the east end of the excavation. This is generally consistent with projection of the mapped contact of Hermosa Formation and colluviums from published small-scale (1:24000) geologic mapping (Pratt, et al., 1969)¹. Bedrock is not readily apparent in photographs of the upper slope of the excavation where it would be anticipated from the small-scale geologic map (see Photos 8 and 9 relative to the mapped contact of Q_{tw} and P_{hi} on Figures 1 and 2). It appears that the original excavation over the tunnel was cut with rough benches as would have been the common practice for a mining operation especially in unconsolidated material. The current slopes are much more uniformly sloped (see Photos 7 through 9). It is unknown if additional excavation was performed to remove the benches or if natural weathering and slope processes removed the benches over time resulting in accumulation of material on the slopes and in the floor of the cut. If so, that material may obscure the sedimentary Hermosa Formation bedrock projected to occur in the upper portion of the excavation slope as described above.

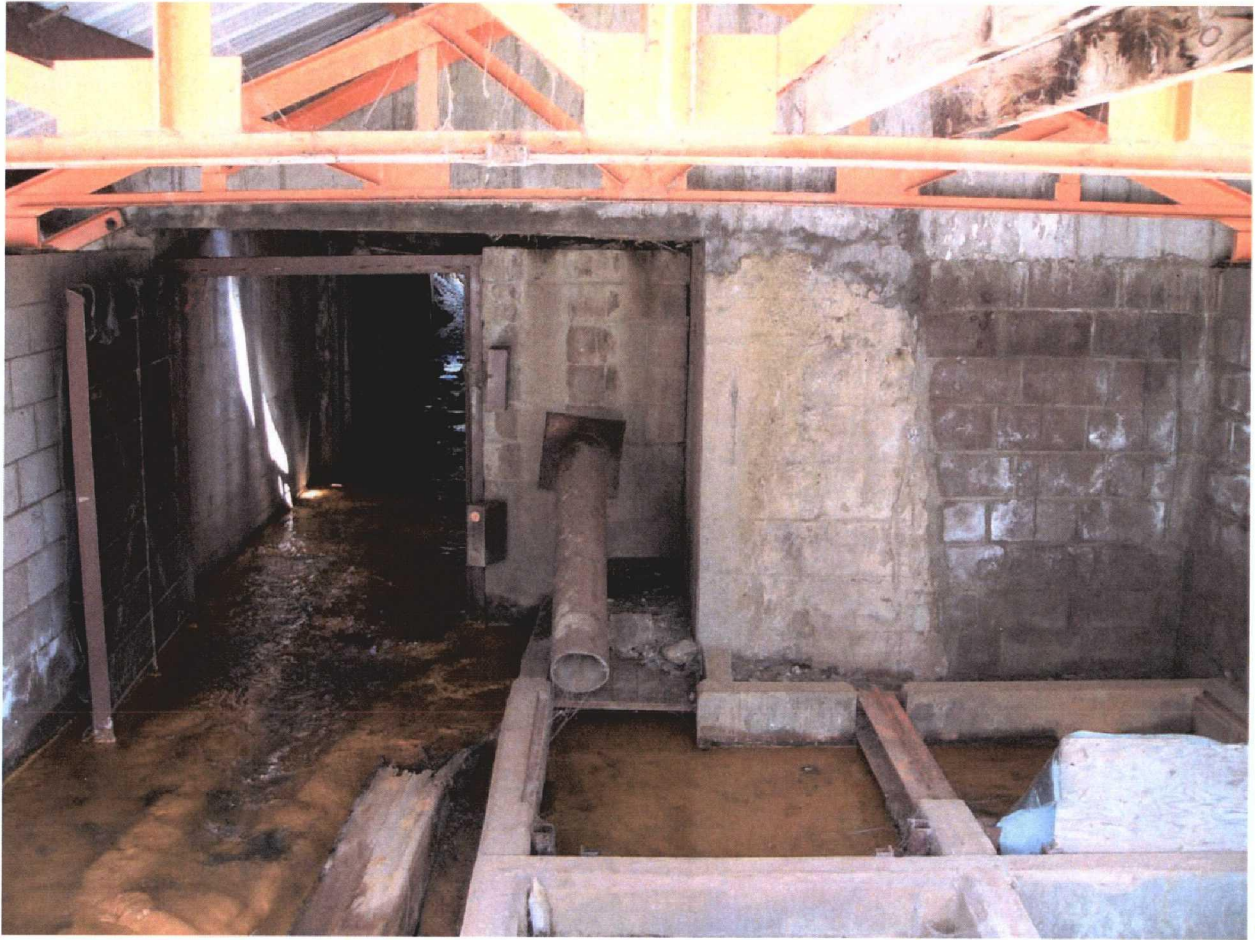
Photo 2 - Existing portal structure

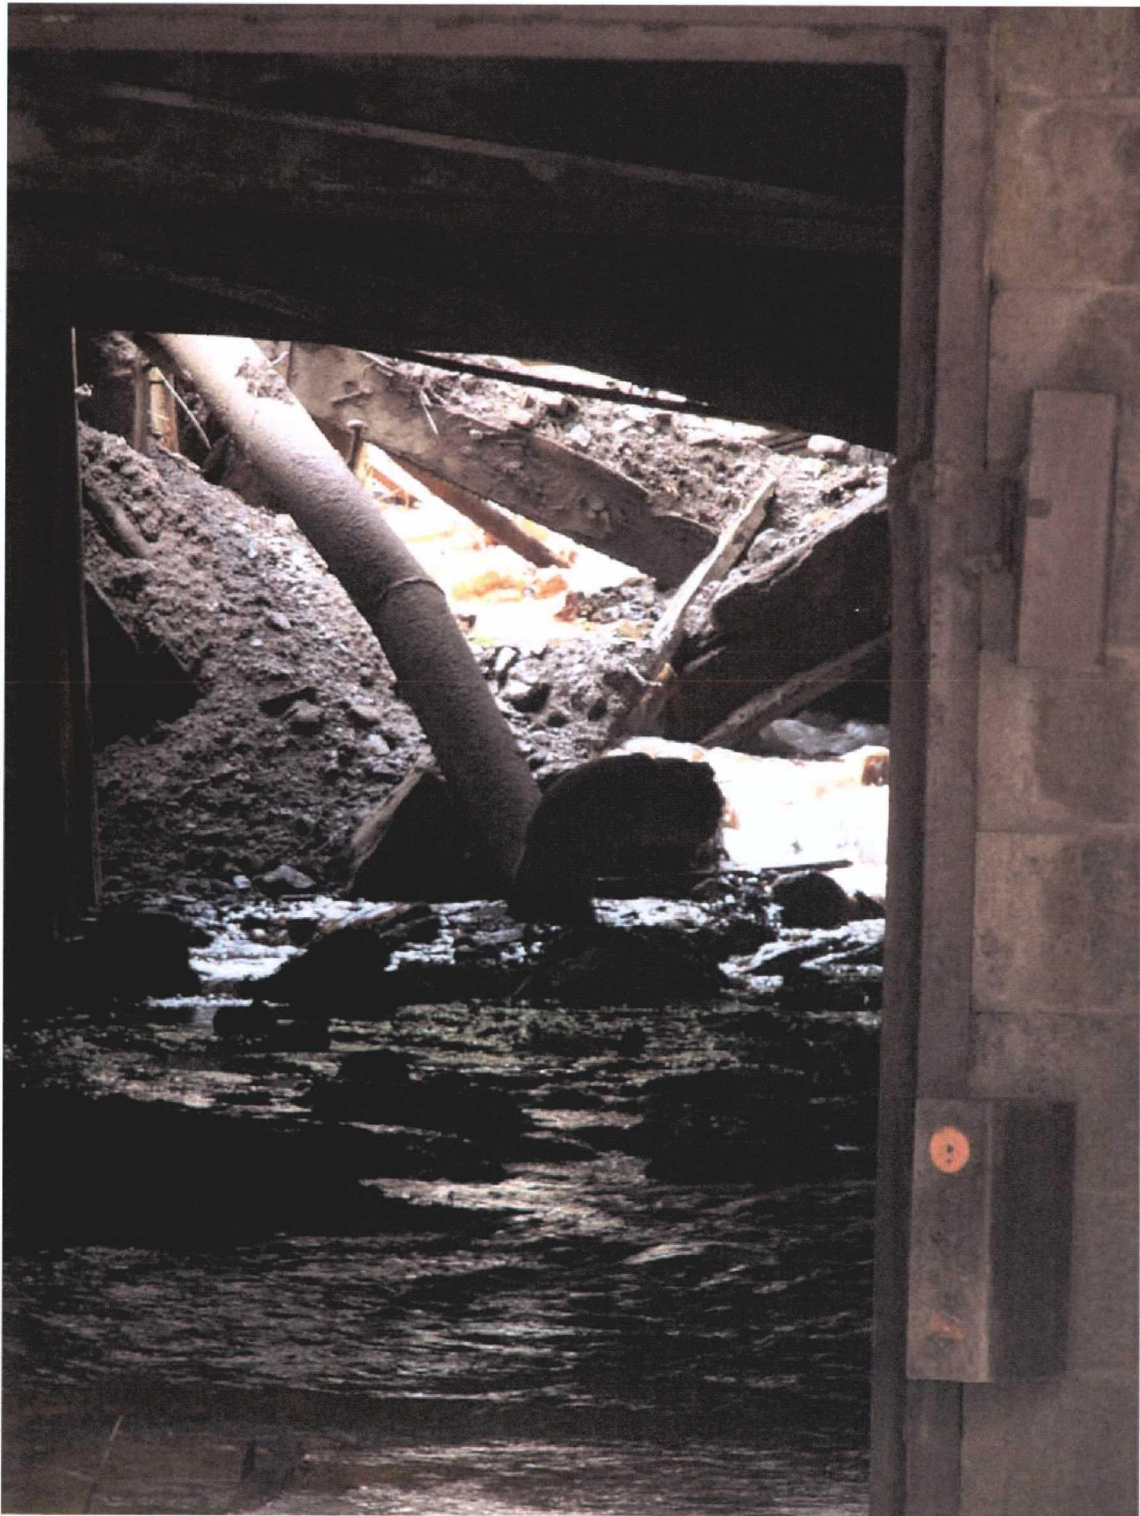
A portion of the St. Louis Tunnel immediately behind the masonry block portal structure has collapsed, apparently due to borrowing of the overlying colluvium/talus deposits (see Figures 1 and 2). The visible portion of the collapse is approximately 200 feet long. A black and white aerial photograph reportedly taken in 1956 shows a major excavation in the area of the existing cut slope above the collapsed tunnel (see Photo 1). When examined in August 2006, the condition at the bottom of the cut was a tangle of broken timbers and lagging among a heterogeneous mix of sand to boulder-size blocks resulting in unstable voids of varying size and shape (see Photos 2 through 6). The discharge from the tunnel was impeded at the upgradient end of the collapse such that flow was observed at the approximate tunnel roof level. This flow then worked its way through the collapsed material to exit at the original tunnel floor grade in the portal.

Photo 3 - Collapse at back (up-gradient) of portal structure

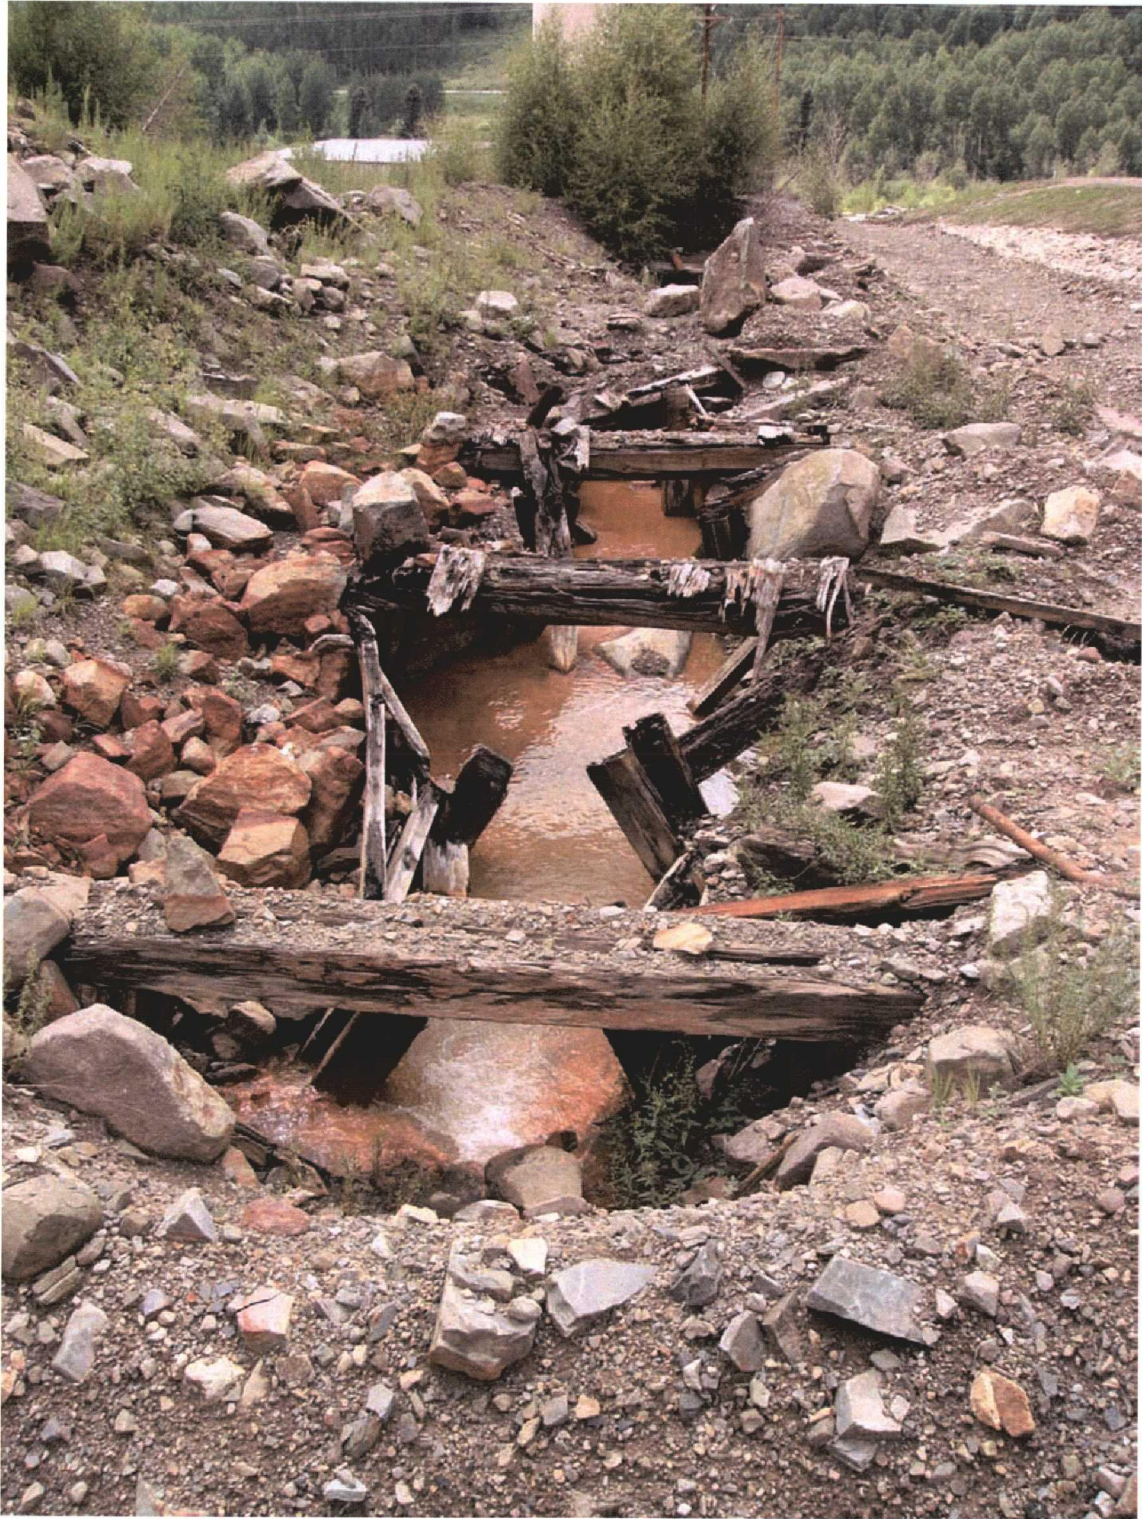
Photo 4 - Collapsed adit; view west toward existing portal structure

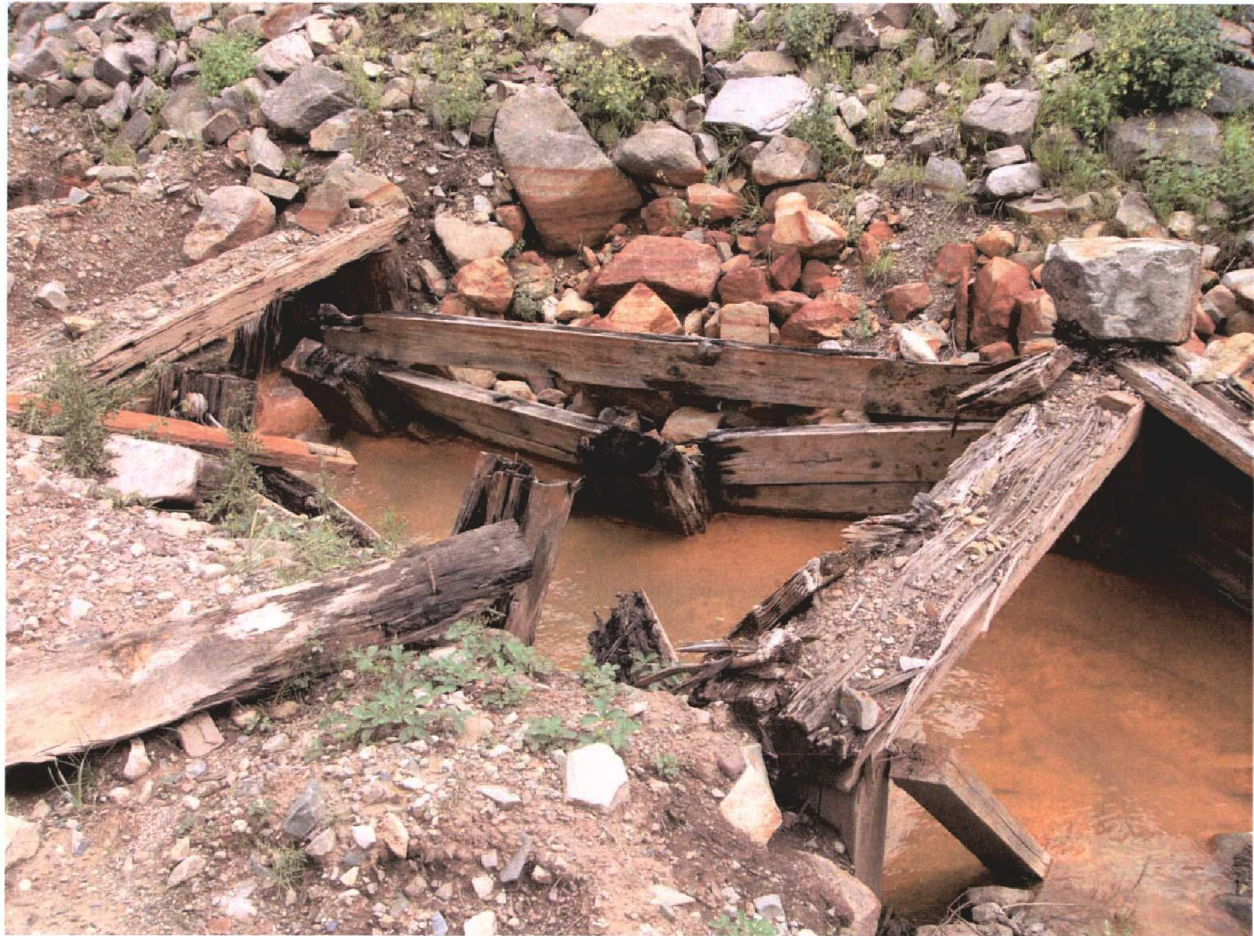
Photo 5 - Close-up of collapsed adit; note crown timbers and continuous lagging

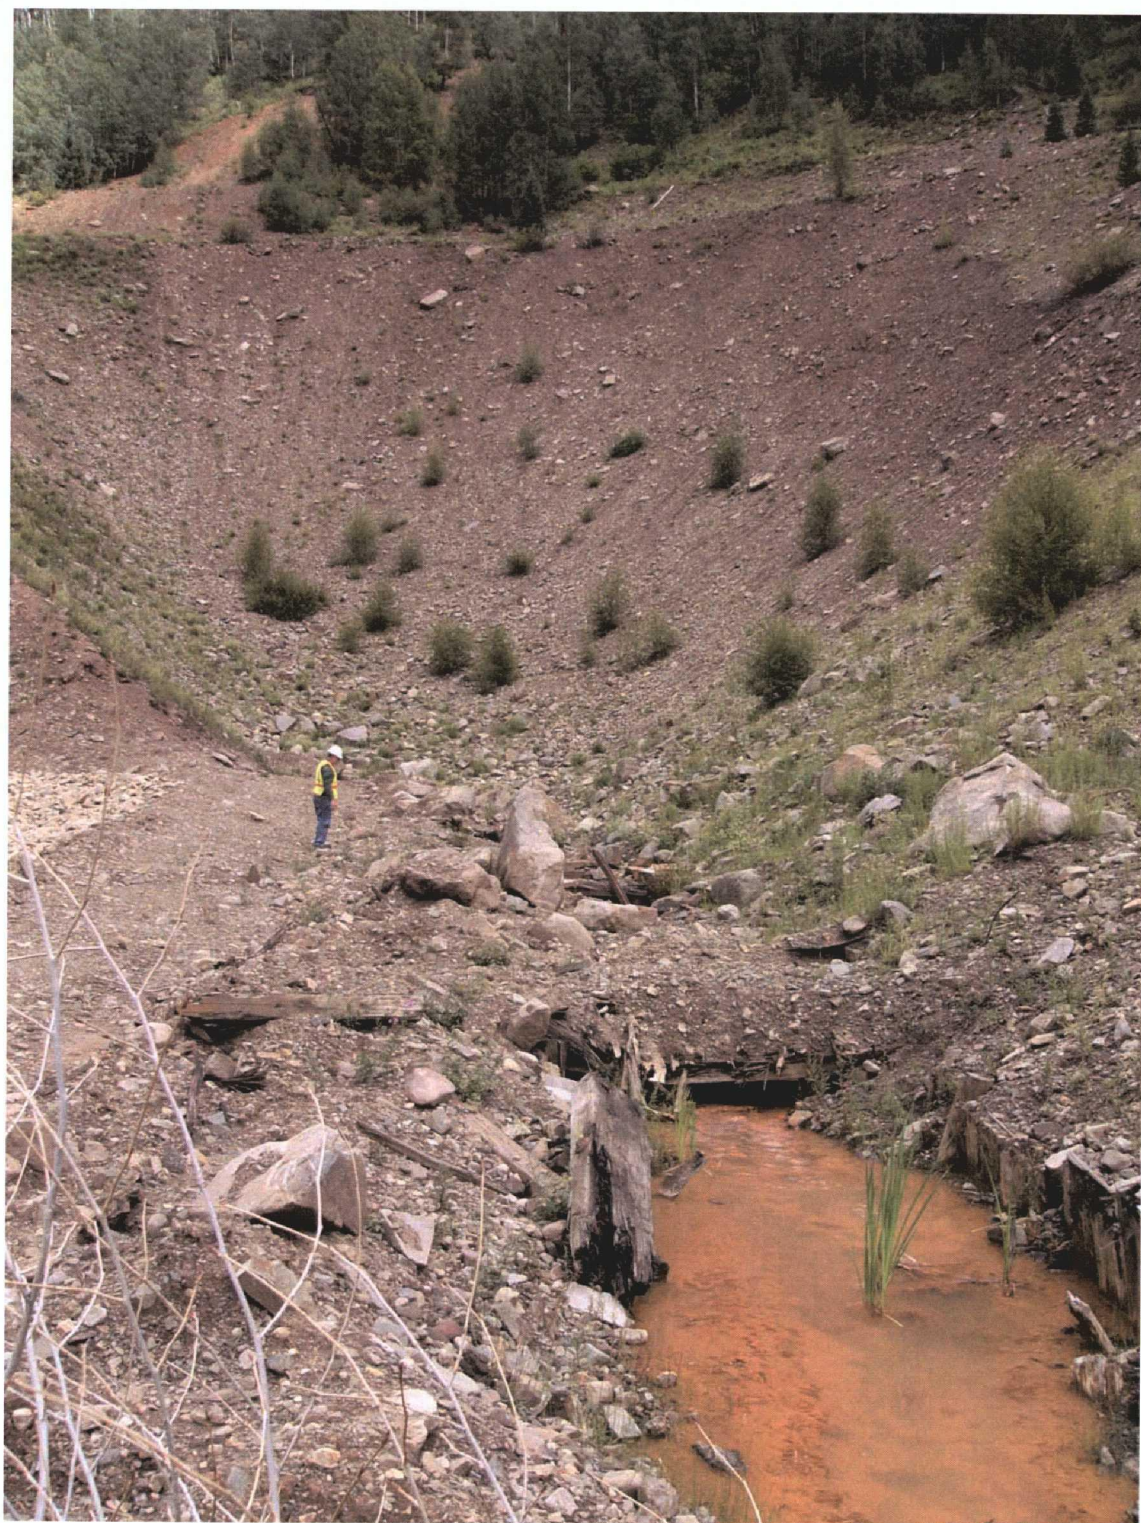
Photo 6 - Collapsed adit; view east into CHC Hill; note excavation over tunnel alignment

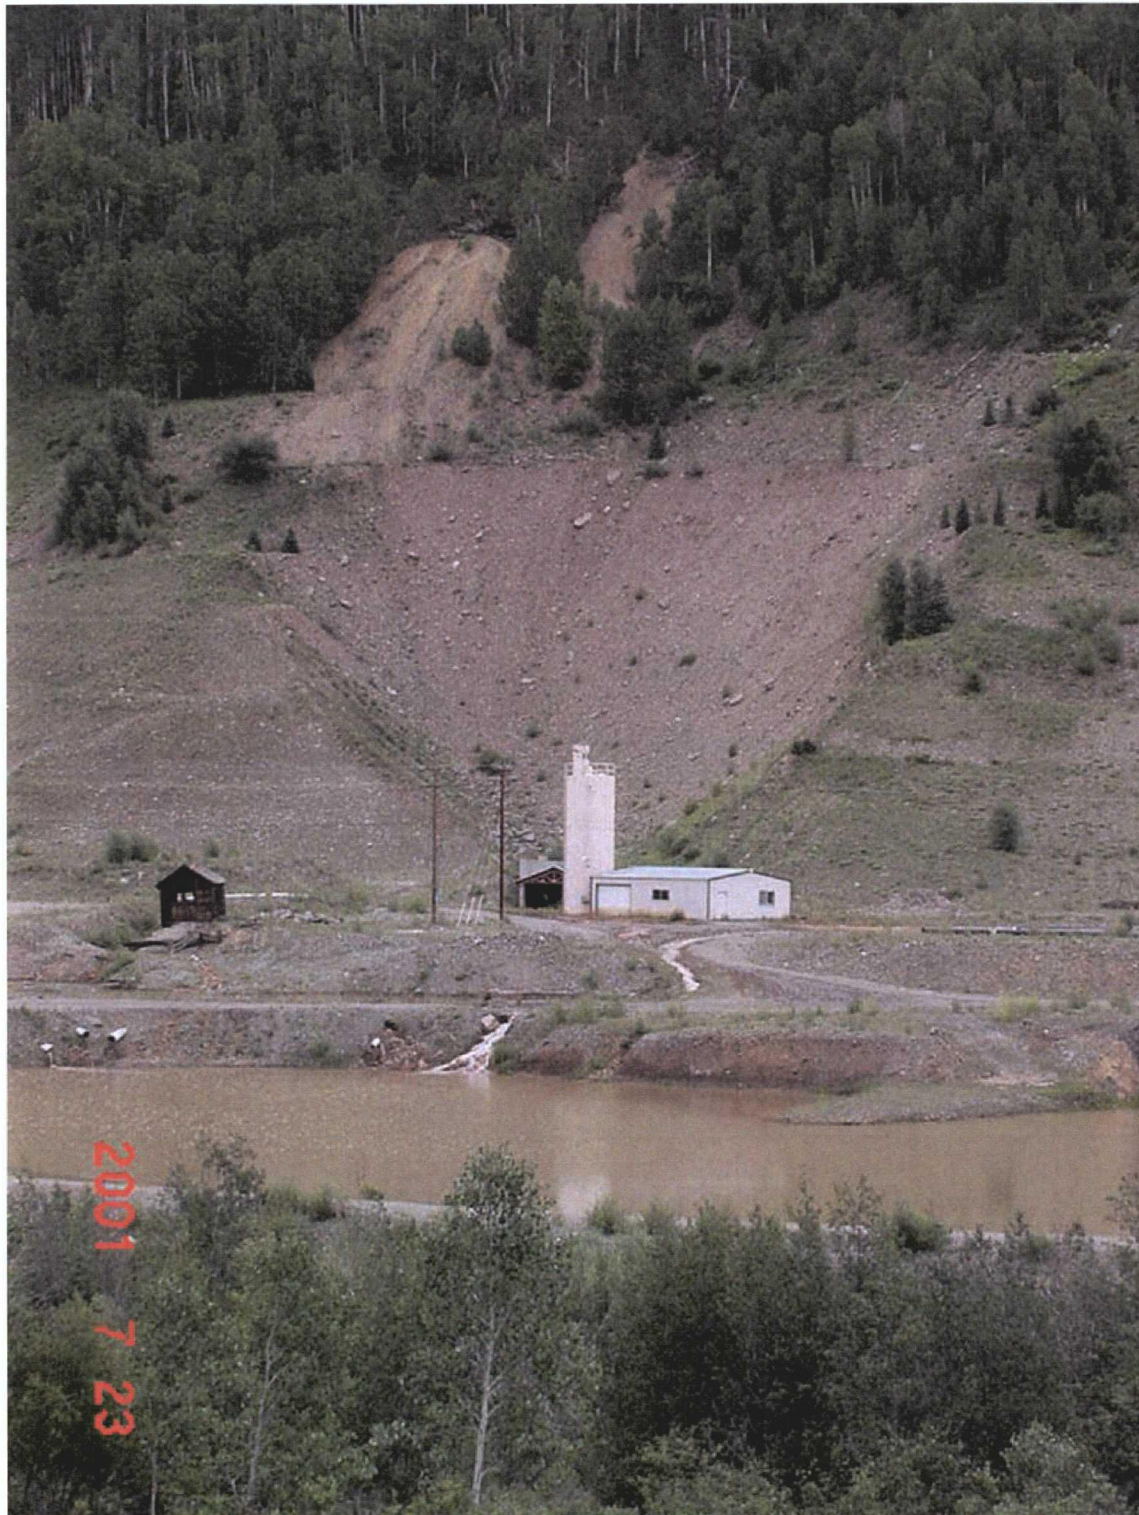
Photo 7 - Excavation over St. Louis Tunnel as of 7-23-01

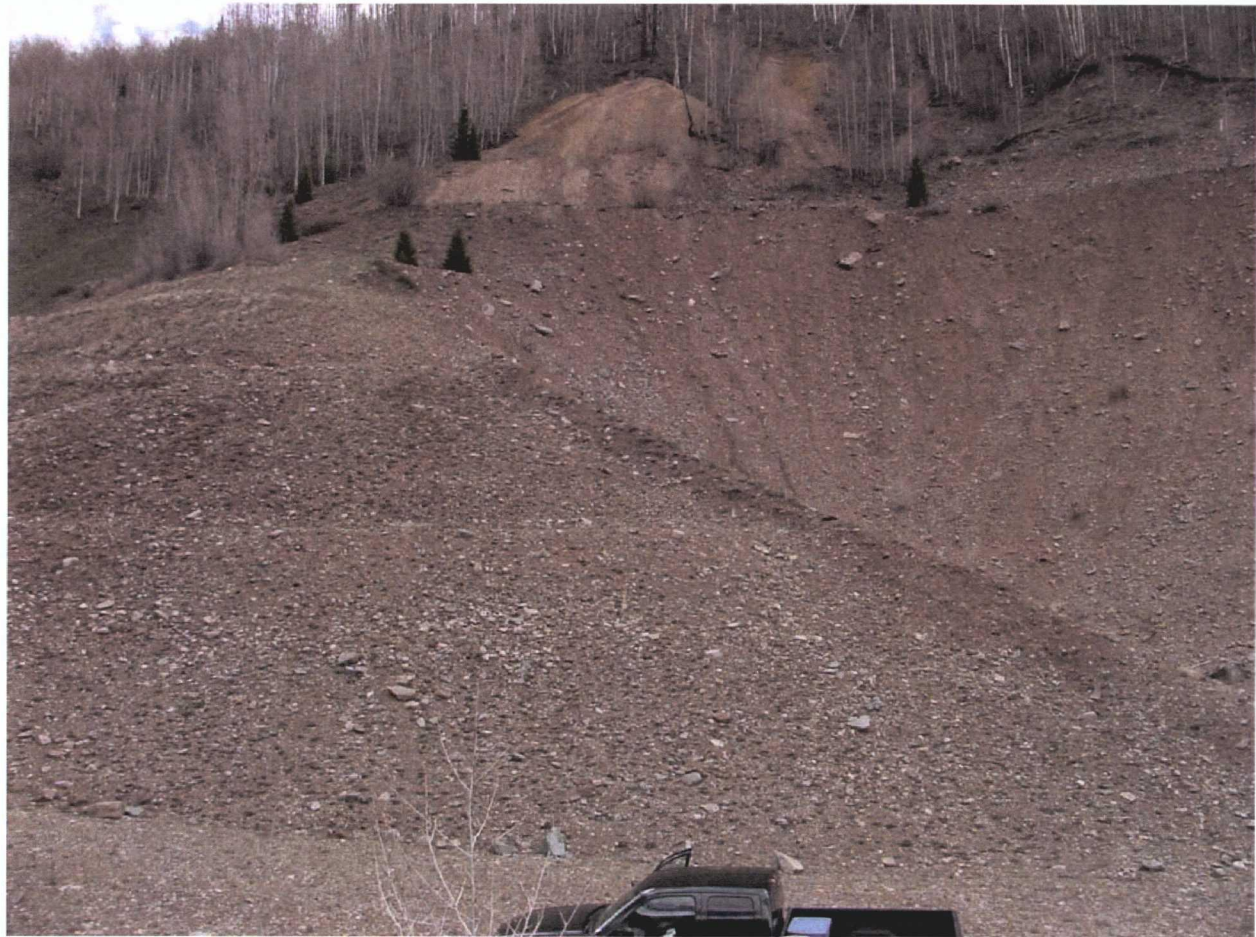
Photo 8 - Excavation over St. Louis Tunnel alignment; view of northeast part of excavation

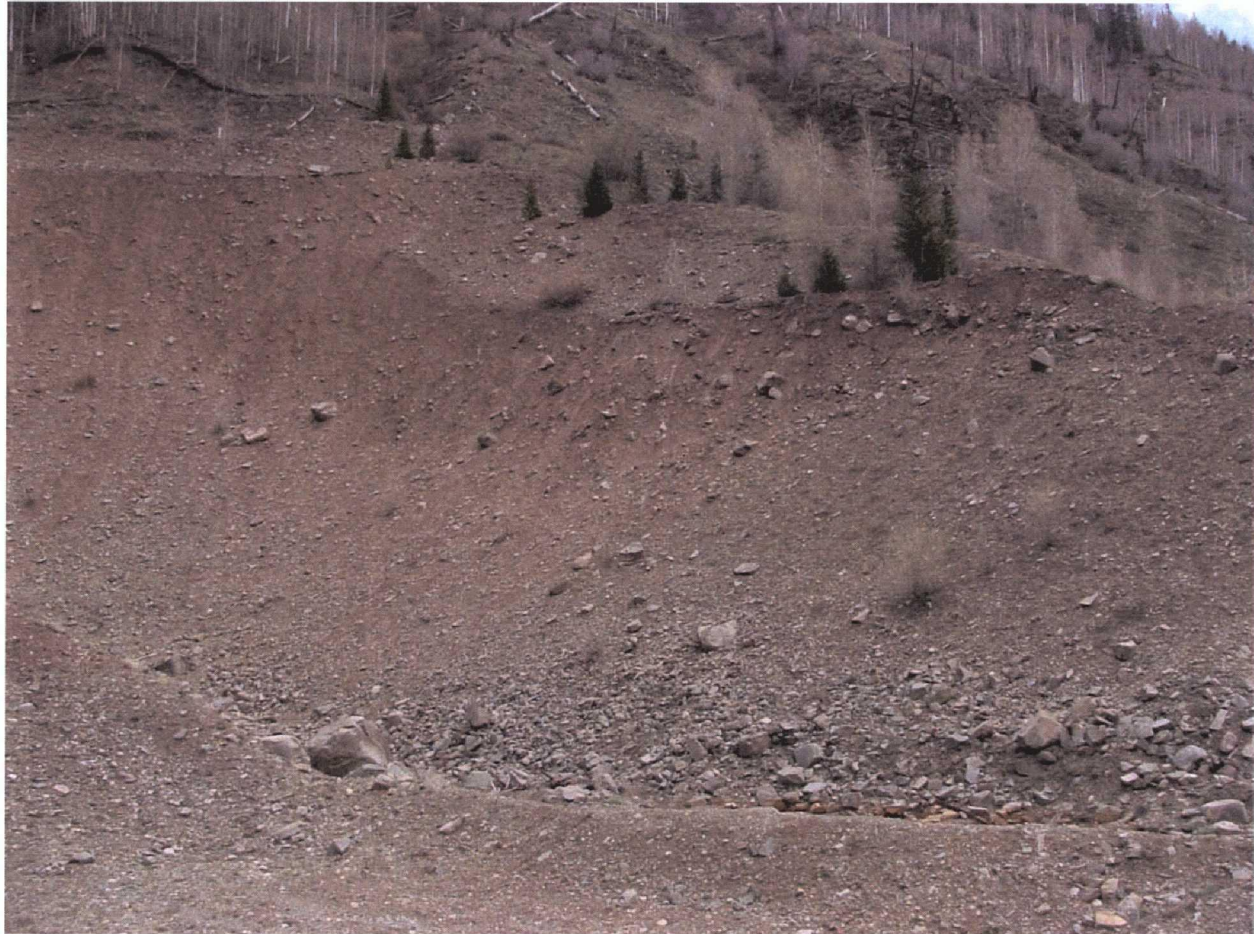
Photo 9 - Excavation over St. Louis Tunnel alignment; view of southeast part of excavation
